ACES-II Seat Roller Study: Findings of Detrimental Friction under High Windblast or Adverse Flight Conditions

Analytical findings of an intrinsic, restraining, high-friction response from the ACES-II Ejection Seat's legacy "seat roller" (a dry metal wheel on a shaft), when subjected to high loads (such as ejections at high speeds or with an aircraft yaw angle). Recommendations are made for improvement.

12 Aug 2015

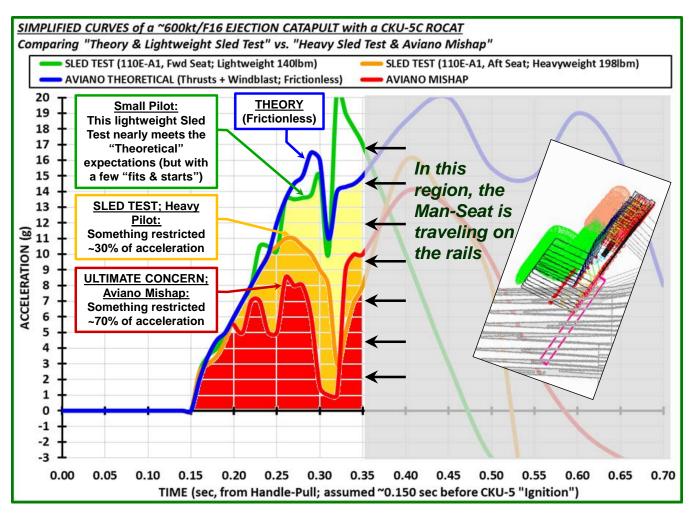
Figure 1 – Summary of "Low-g" Artifact and Its Severity Increase with Loads on Seat Rollers

The certainty of Artifact #1 (low-g period at top of rails) was increased by the expectation that – at these high speeds (~600 knots) – windblast should have been "getting underneath the seat" and increasing the spinal acceleration. Theoretically (Figure 1 - blue line; frictionless rollers), windblast should superimpose on the CKU-5 ROCAT's catapult and sustainer spinal vectors, particularly in the "leaned back" aircraft rail (34-deg, vs. 17-deg) and exposed man-seat (no windscreen) of the F-16 aircraft. Figure 2 confirms this wind-assist via hand calculations. Rough expectations then sum the catapult thrust (~3500 lbf; ~10g) with the windblast "getting under the seat" (~6.7g, as shown in Figure 2) for a sum of 16.7g. Thus, a hand-calculated expectation of a high-speed F-16 ejection would be a spinal acceleration peaking at ~15-20g during catapult phase, and the specific hand calculation (~16.7g) also matches the peak theoretical (frictionless) 6-DOF ADAMS model prediction (Figure 1; blue line).

As shown in Figures 1 and 3 (the red curves; spinal acceleration of the Aviano mishap); instead of finding this 15+g spinal acceleration during the Aviano's catapult phase, the investigation noted a "low g" performance; intermittent spinal acceleration, with a peak of only ~8g (instead of ~15-20g), and with regions down to ~0-1g. For perspective on the seat position (Displacement = Velocity x Time); recall that during a 50msec period (such as from 0.280sec to 0.330sec) – a man-seat traveling at ~40fps would traverse about 2 feet of the rail. So, this ~0-1g "low-g dropout" period was not a "brief transient" (as it may appear on a time-scale), but a long-stroke restraint or loss of thrust, occurring to the seat.

This contrast between the prediction (~15-20g) and observation (0-8g) drew the initial investigative concern – and in general; the finding that windblast caused a *decrease* in the man-seat's acceleration, rather than an increase, led to the logic of investigating friction (seat roller friction) as a potential cause of the restrained man-seat motion.

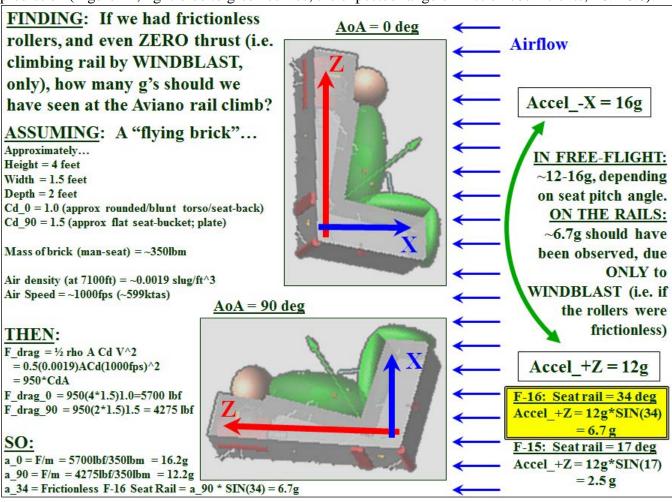
Figure 2 – Hand-Calculation of Aerodynamics on a Man-Seat Emerging at 7100ft-msl & 600kt

Note that this simplified relation (F_friction = ma – PA) excludes what may have been an additional "wind assist" ascending the rails. As shown in Figure 2, a frictionless seat roller should allow additional man-seat acceleration due only to vectored wind forces "getting under the man-seat" on a 34-deg reclined F-16 aircraft rail.

However, as noted: This measured friction was simultaneously overcoming what is presumably up to ~6.7g (see Figure 2) in additional wind-assist; acceleration which should have been measured as a "negative friction" (acceleration exceeding the F=PA value), had roller friction been zero. Therefore, the actual seat roller friction may have been thousands of pounds higher than this F=ma-PA measurement, in order to have finally been measured as a "restraint" on the man-seat (or on the CKU-5 ROCAT).

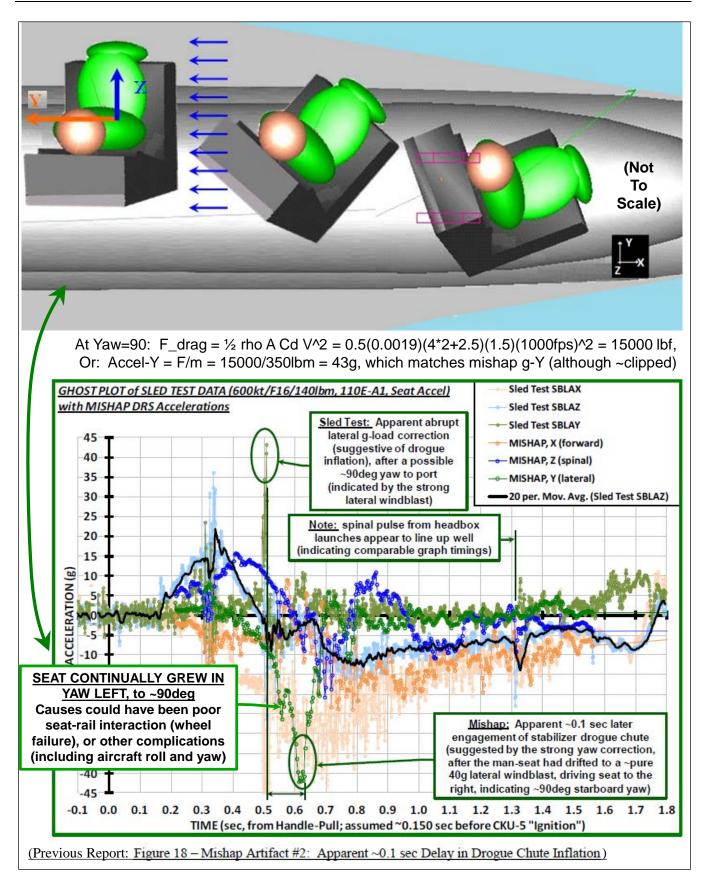
Figure 4 – Recap of Artifact #2; Apparent Man-Seat Yaw of ~90deg plus Drogue Chute Delay

As for "Artifact #2" (the drogue inflation delay, aggravated by the seat having drifted to ~90-deg Yaw) – this seat rotation in yaw may have been caused by the perturbing ambient aircraft yaw and roll, or by a seat roller failure, or – potentially - a combination of both. As shown in Figure 4 (which includes an excerpt from Reference (1)) – the lateral seat acceleration of the Aviano mishap's man-seat (shown as the lowest green dots) grew steadily from the point of man-seat departure from the aircraft's seat rails, ultimately reaching (possibly clipping) at ~43g's – which indicates the man-seat yawed ~90deg against the windblast. The period of this yaw was during free-flight; between seat-rail departure (t=0.3 sec, on the graph) and drogue chute inflation (t=0.6 sec, which appears to be ~0.1 sec later than a comparable sled test). The rate of this yaw is uncertain, but *averages* a strong rate of 300 deg/sec = 90deg/(0.6s-0.3s). When the drogue chute inflated, the correction "snapped" the man-seat back to face-forward. While the cause of this progressive man-seat yaw is not known, motion difficulty on the rail (wheel friction and failure) is among the possible drivers (along with aircraft roll and yaw, intrinsic man-seat aero-instability, pilot shift and slump, asymmetric helmet movement, asymmetric limb flail, etc.).

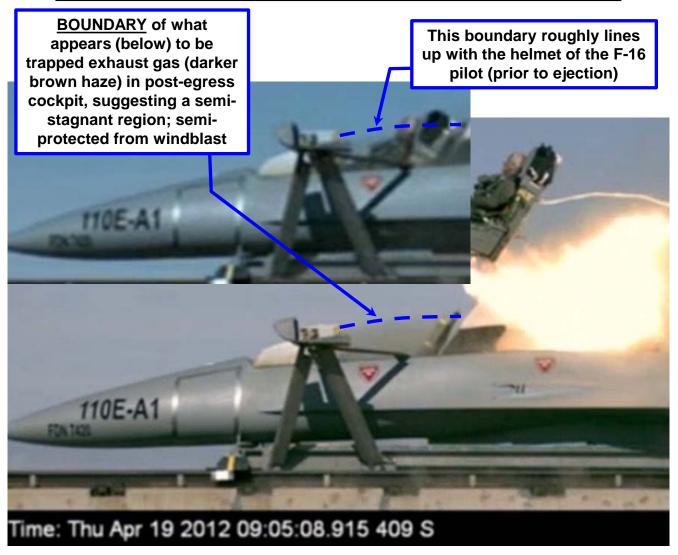
Figure 5 – Sled Test Example of Windblast Emergence (Between Elbow and Head Height)

Estimating Windblast Emergence Thresholds from Sled Test 110E-A1 (600 KEAS, F-16 dual seat)

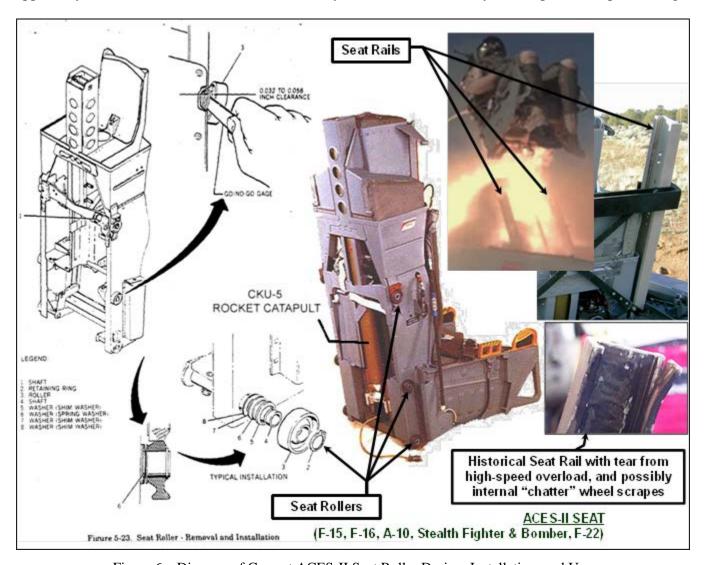
Figure 6 - Diagram of Current ACES-II Seat Roller Design, Installation, and Use

The current configuration of the ACES-II Seat Rollers is shown in Figure 6, from TO 13A5-68-2 (and is essentially the same seat roller design since conception in the late 1970's – and that roller design itself was inherited from the prior-generation, "ESCAPAC" seat). As indicated, the ACES-II Seat Rollers apparently are hand-assembled steel wheels on dry metal shafts, with only metal spacers for positioning.

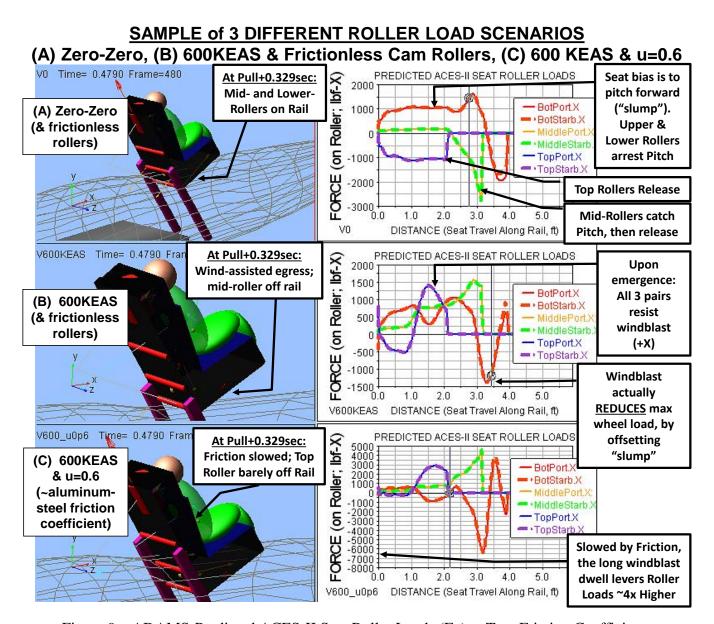
Figure 9 – ADAMS-Predicted ACES-II Seat Roller Loads (Fx) at Two Friction Coefficients

As summarized in Figures 9 and 10, all four sets of results indicate the current seat roller friction coefficients are sufficient to detrimentally slow the man-seat and nominally quadruple the roller loads (by increasing the dwell time in the windblast), eliminating the majority of tail clearance margin, and observably reducing apogee.

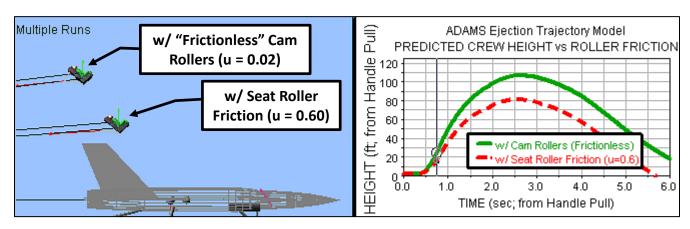
Figure 10 – ADAMS-Predicted ACES-II Tail Clearance and Apogee at Two Friction Coefficients

Figure 10 shows the continued flyout of Scenarios B and C (the two 600KEAS friction variants, from Figure 9), illustrating the reduced tail clearance (reduced from yards to feet), lower apogee (reduced from ~110ft to ~80ft), and reduced time of flight (~1.5 seconds less to complete the parachute stabilization, deceleration, and pendulum swing).

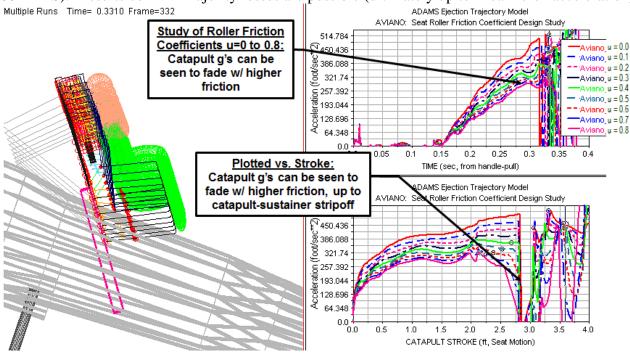
Figure 11 – Results from ADAMS Design Study of Seat Roller/Rail Friction Coefficients

Figure 11 shows ADAMS-predicted man-seat spinal accelerations for the studied range of ACES-II Seat Roller friction (u=0 to 0.8), plotted against time (upper right quadrant) and seat motion (lower right quadrant), for flight conditions comparable to the Aviano mishap (~18 deg dive through ~7100 ft-msl at ~599KEAS). Results confirm majority losses are possible (ultimately up to "near zero" acceleration).

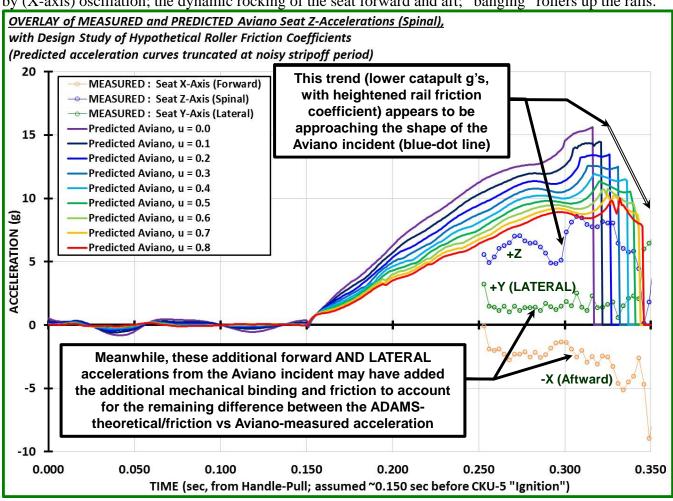
<u>Figure 12 – Superposition of ADAMS Design Study with Aviano Seat Accelerations</u>

These same results (cropped to only show the CKU-5's catapult phase; excluding the sustainer onset, for clarity), are shown in Figure 12, with the Aviano Mishap seat accelerations overlaid. This overlay reminds that – in the mishap – additional lateral accelerations were simultaneously occurring, so the additional loss in spinal acceleration may be explained by the additional friction from these lateral loads, and further "intermittent drops" in spinal performance (such as at t = 0.300 sec) may have been caused by (X-axis) oscillation; the dynamic rocking of the seat forward and aft; "banging" rollers up the rails.

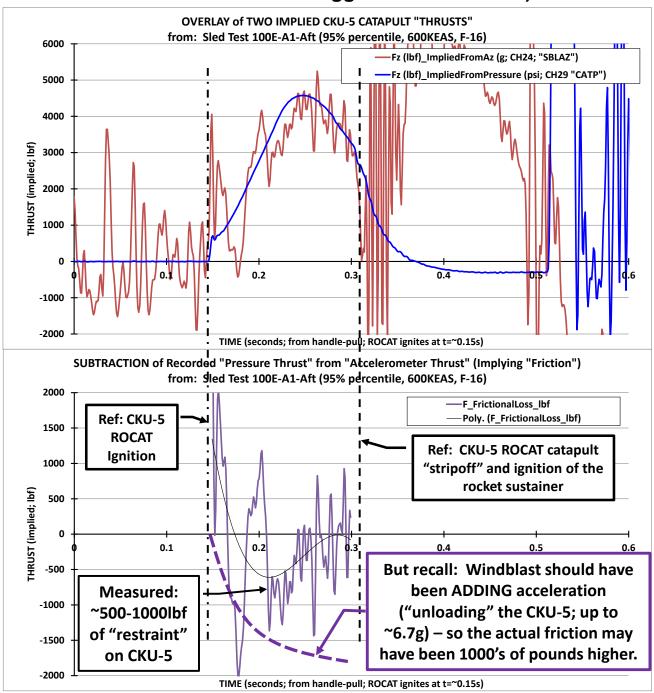
Figure 13 – Sled Test Indication of Seat-Rail Friction (at "Straight and Level" Conditions)

Regardless (i.e. even if neglecting the expected "wind assist"), the seat roller friction is observed to have been at least \sim 500-1000 lbf. This magnitude of restraint is \sim 1.5 to 3g of egress loss (a=F/m, with a \sim 350lbm man-seat); up to \sim 30% of the CKU-5's \sim 1000-4500 lbf catapult performance. So, even this "small" amount of friction (\sim 500-1,000 lbf) is a significant portion taken from a \sim 3500 lbf ROCAT, and appears to be of a comparable magnitude to the loss described in Figure 1 (\sim 30%).

In either case; indications are that seat roller friction is causing real-life losses in egress performance.

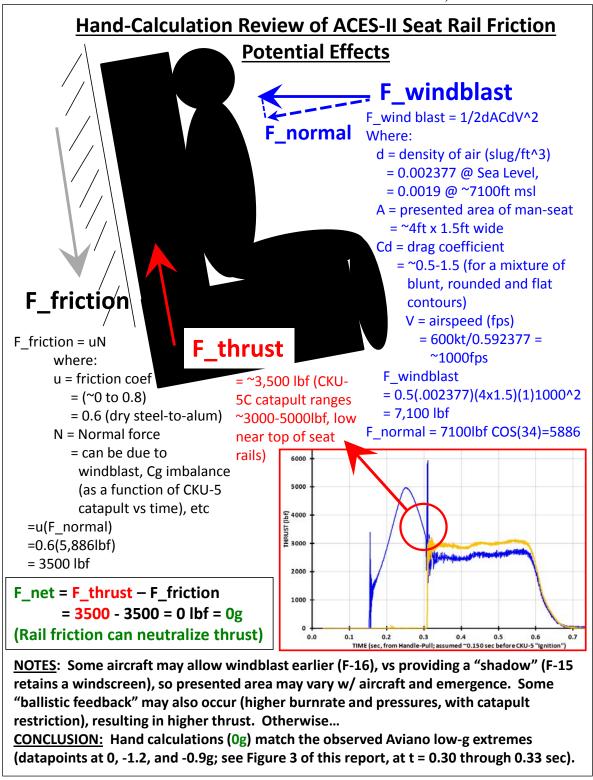
Figure 14 – Hand Calculation Supporting Conclusion of Causal ACES-II Seat Roller Friction

As shown in Figure 14, hand-calculations indicate a similar magnitude of response (that seat roller friction can match – or overcome – the nominal thrust of a CKU-5 ROCAT).

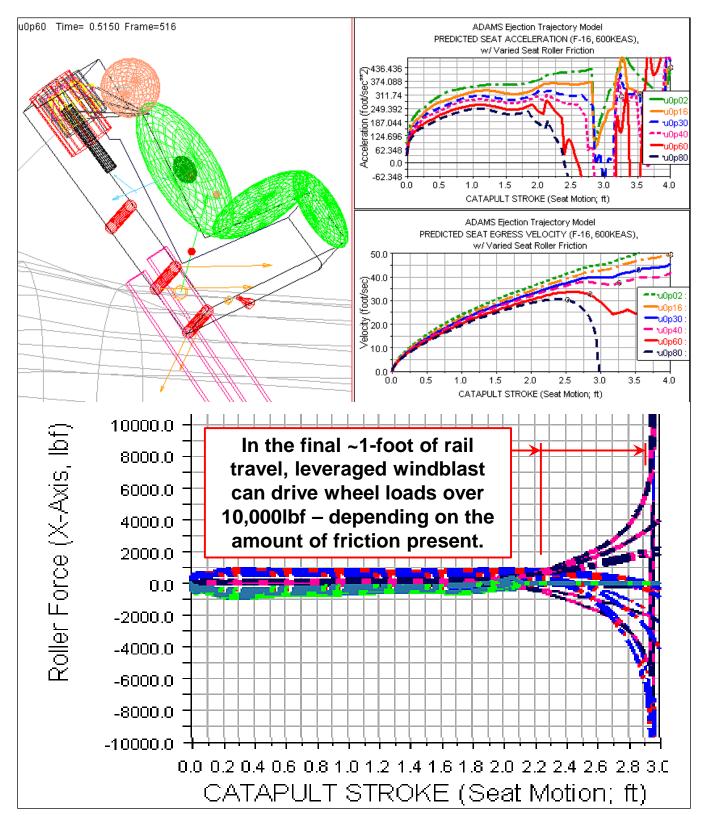
Figure 15 – Results from ADAMS Design Study: Friction Can Drive Roller Loads Above 10,000bf

- SLOWER MOTION CAUSES HIGHER FORCES. If the dwell time of the man-seat at the top of the rails is brief (i.e. a lightweight pilot "shooting up the rails" at the highest speeds), then there may be insufficient time for the windblast to fully "rock back" the seat to cause backloading of the seat rail and rollers. Conversely, if the dwell time of the seat at the top of the rails is large - sufficient to fully "rock back" the seat against the rails (enough to cause full deflection; i.e. semi-static reaction loads), then the windblast is able to fully transfer mechanically into the seat rails and rollers. In this case, due to the leverage advantage of having only two pairs of rollers engaged while the man-seat emerges, the middle rollers could arguably approach a sharing of ~14,000 lbf between the two wheels (~7,000 lbf per wheel), due to resisting both the windblast (translational) and the leveraged reaction (bending moment) with the bottom rollers. Meanwhile, the lower rollers are rocked FORWARD, and share ~7,000 lbf (~3,500 lbf per wheel), from this same bending moment. Prior to this (i.e. before onset of windblast, or without wind loads; a "zero-zero" ejection), the bias of a man-seat during catapult is to "rock forward" (rather than aerodynamically "rock backward"), as virtually all of the manseat mass is in front of the ROCAT's catapult line-of-thrust, rails, and rollers. Therefore, the "dwell time" in windblast at the top of the rails is primary to the seat roller loads, as a short dwell time will not allow aerodynamic loads to be transferred to the seat rollers (zero-wind max wheel load: ~1500 lbf per wheel), while a long dwell time will allow the full aerodynamic and leveraged forces to apply on the rollers (i.e. max load, with thrust and dynamic collisions, could be on the order of $\sim 10,000$ lbf per wheel).

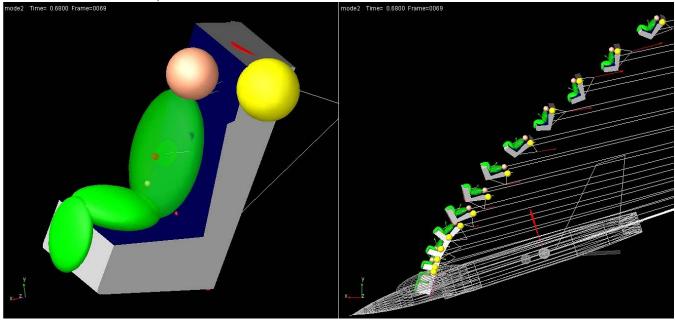
Figure 17 – Example of a Deviation Analysis; Aerodynamic Helmet on Pitot Tube (from ADAMS)

Approximately two-dozen ADAMS model studies (experimental scenarios) were exercised, to explore the sensitivity of the DRS's recorded accelerations to various anomalies, such as pilot Cg shifts ("up and back" from Air Force defaults, for tall/thin body shapes), boot flail aerodynamics, arm flail mass and aerodynamic effects, drogue chute inflation delays, CKU-5 ROCAT performance variations, aircraft pitch and roll (and rate) effects, atmosphere effects (wind, density altitude based on colder weather), seat rail structural failure and early release at top of rails (including asymmetry), etc. No conclusive match was found, to explain "artifact #1". As an example of these analyses: Figure 17 shows the flyout predicted for this incident, if the aerodynamics are altered by the snagging of a helmet on the port pitot tube of an ACES-II seat).

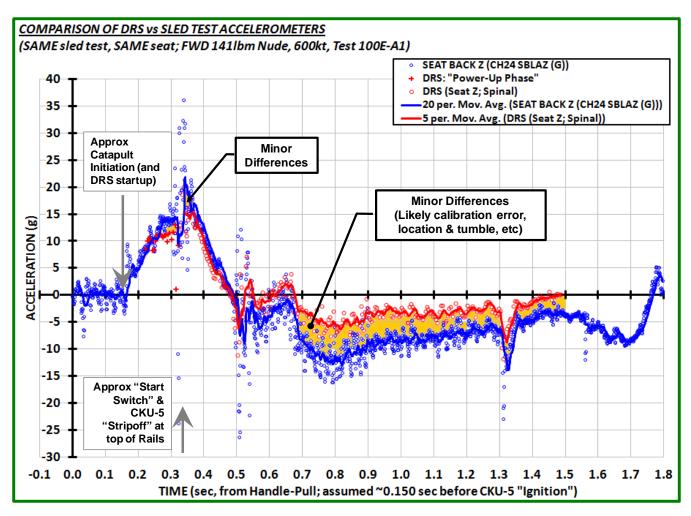
Figure 18 – Proof of DRS Accuracy; Mostly Complies w/ Lightweight Sled Test Instrumentation

Confirmation was achieved (via review of sled test data, containing both "high-fidelity" accelerometers and onboard DRS) that the DRS appears to be capable of accurate readings; tracking well in both time & magnitude with the "high fidelity" accelerometers onboard the sled test seats. Figures 18 and 19 show this good match, between onboard DRS readings (on back starboard of seat) and their comparable sled test instrumentation measurements from additional high fidelity accelerometers (mounted on the back port of the same seat), for the same ejection event. This finding provides good confidence in the DRS design and concept (and suggests DRS errors were NOT the cause of Artifact #1).

It should be noted that the DRS intrinsically has a ~7.5 deg mounting alignment difference, off the Z-axis of the seat, so there will always be some (small) numerical, trigonometric deviation from "pure" Z-axis readings, prior to the DRS data being converted from this misalignment.

Figure 18 also captures the "good" (expected) performance of the catapult and 600kt-emerged sustainer phases; exhibiting 10+g spinal accelerations, throughout the regime of being "at the top of rail, +/- 1ft". Figure 18 also confirms the good timing-alignment achieved (aligning spinal acceleration timing marks from the headbox initiation at t = 1.3 sec, and earlier at top-of-rail "stripoff"). This finding confirms two things; the need to use a ~0.060sec delay (battery warm-up period) to start considering as the DRS's time of "first data", and that this "first data" is the initial "Power-On Phase" data (not the subsequent "Ejection Phase" data, which begins at the "Start Switch"; near the top of the rails). Further, this finding shows two more things; that the DRS's "Power On Phase" data (marked as red "+" signs, vice the "Ejection Phase" DRS data, marked as red circles) is largely capturing the majority of the CKU-5 catapult phase, and that the Power On Phase is measuring this catapult performance fairly accurately.

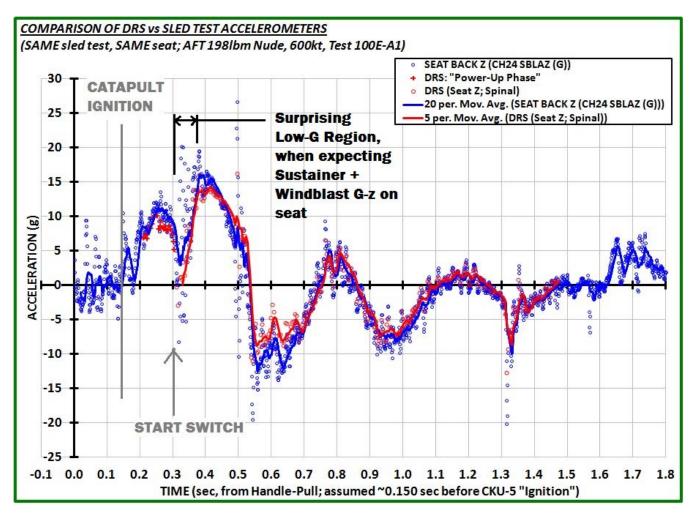
Figure 19 – Proof of DRS Accuracy; Mostly Complies w/ Heavyweight Sled Test Instrumentation

Figure 19 captures this same successful instrumentation as Figure 18, but also appears to have captured an "artifact #1" event of the spinal g-load dropping out to near-zero values within a foot or two of the top of rails (near the end of the catapult, and the beginning of sustainer phases of the CKU-5).

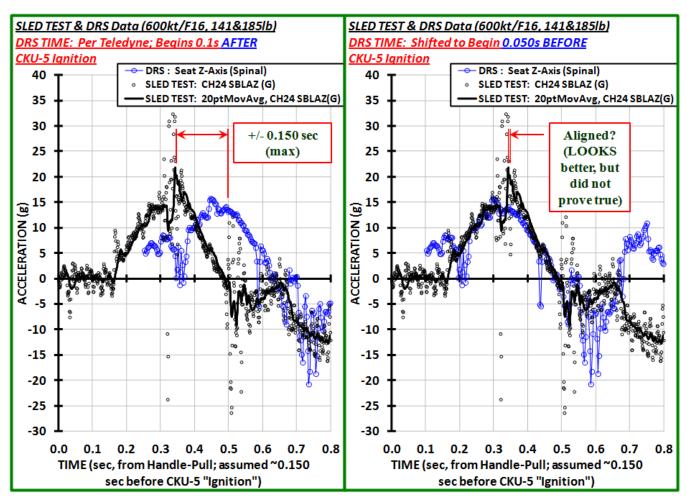
Figure 20 – Illustration of the Discussed "Time Shift", Cosmetically Fixes Artifact #1 & #2

Previously, as shown in Figure 20: Multiple discussions had occurred, ranging from +0.100 sec delays (spec max), to -0.050 sec delays (if sneak paths or data recordings or phases were misunderstood), and – the latter (shifting time ~150msec earlier than the "max spec") did make the period of the CKU-5's operation appear "nominal", rather than "anomalous". However, these further studies of the sled test accelerometers and DRS data – complete with time-datums of CKU-5 stripoff, and later headbox launch

- confirmed that the nominal delay of ~0.060 sec (from CKU-5 initiation) is the proper alignment. The appearance of "nominal CKU-5 function", when shifting the DRS data to begin ~0.050 seconds BEFORE the CKU-5 (reportedly impossible), or deleting the ~0.090 second "Power Up Phase" data, appears to be only a cosmetic coincidence.

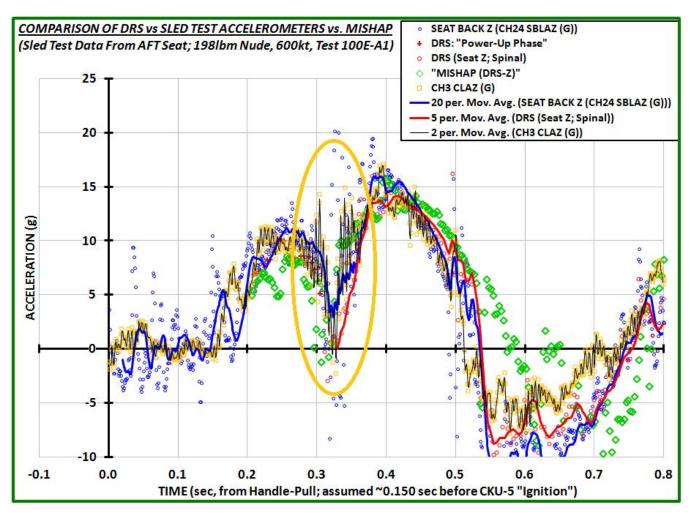
Figure 21 – Proof that Seat Flexure Didn't Cause Artifact #1 (Manikin Chest Accel Agrees w/ DRS)

As shown in Figure 21, confirmation was achieved that the "torso" of the pilot accelerates reasonably well with the seat-back (suggesting Artifact #1 was not caused by modal frequencies of flexure in the ACES-II seat's structure). The sled test's aft seat-back accelerometer (Channel 24, SBLAZ), manikin torso (Channel 3, CLAZ), and DRS-Z all three agree, showing that the cause of the "low-g dropout" is NOT merely an instrumentation accident, or a localized "slump" or structural flexure artifact in the manikin or seat, but rather (apparently) a true, macro, seat-motion artifact. Additionally, the mishap's DRS-Z exhibited this same artifact; spinal acceleration largely "zeroed" for ~0.030 to 0.050 seconds, near the top of the rail.

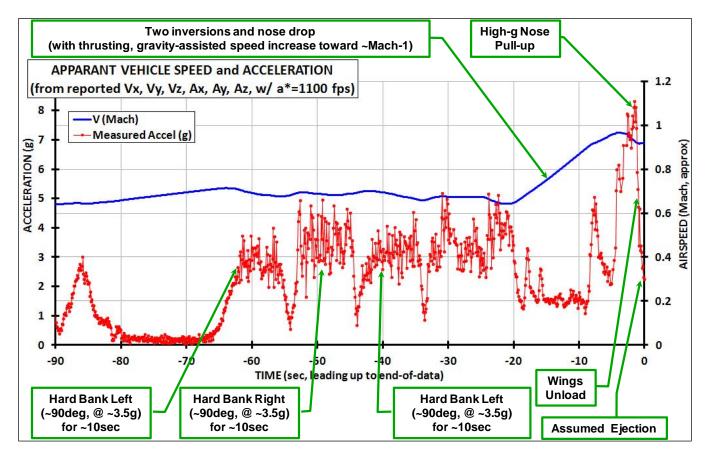
Figure 22 – Acceleration Report of Aircraft for 90sec Prior To Ejection (at ~2.3g)

Consideration was given that the ongoing "ambient" aircraft acceleration (about 2 g's) at the time of catapult firing could have "decreased" the CKU-5's catapult performance. The acceleration profile for the 90 seconds prior to the assumed ejection is shown in Figure 22, along with approximate Mach number. However, logical examination disproves this aircraft g-load from explaining artifact #1 ("lowg", including during catapult phase). First, while the aircraft was "bellying out" (positive AoA) as a high-g (~8-9g) "nose pull-up" maneuver, and retained approximately ~2-2.5g of this positive AoA at the time of ejection, "subtraction" of this ~2g from catapult performance would not explain the regions of catapult-phase acceleration which appear ~5-10g below the expected 10-15g performance, particularly during the "mid-catapult" g-load dropout of several g's, as shown in Figure 21, at approximately 0.25 seconds. Second, a contained solid propellant ("catapult") performance generally "self-compensates" against restraint, by increasing burn rate at higher pressures, so a superimposed "2g" aircraft environment would generally be expected to have a "less than 2g" reduction on the catapult's thrusted acceleration. Third, since the seat's DRS is mounted to measure inertial acceleration of the seat (not acceleration from the aircraft, or "infer" seat acceleration from thrust measurement), the aircraft's acceleration would be INCLUDED (i.e. somewhat "added") to the measurement of the CKU-5 driving performance on the seat. So, if the DRS measures "+5g" of spinal acceleration during the catapult phase, during a time when the aircraft is itself "pulling +2g" of spinal acceleration, then that

measurement indicates a net acceleration of the seat (departing the aircraft; catapult-driven) of only +3g (i.e. LESS than the DRS measurement of +5g).

Therefore, it would not be a reasonable attempt to explain a "low 5g catapult-phase acceleration" by suggesting the "aircraft g's inhibited this measurement", or that the ambient 2g aircraft acceleration should be "added" to this DRS reading, to report that the "actual ejection g-load was 7g". Conversely, the superposition of accelerations works the opposite; a 2g aircraft acceleration superimposed would suggest the CKU-5 catapult only added ~3g additional, to be measured as +5g by the DRS.

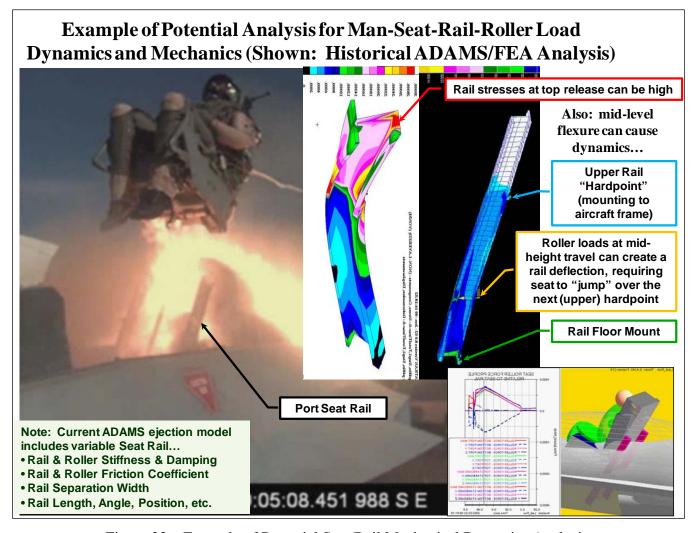
Figure 23 – Example of Potential Seat/Rail Mechanical Dynamics Analysis

While no analysis has been repeated for this particular scenario (high speeds, F-16 recline, heavyweight pilot, CKU-5C booster profile), Figure 23 shows an example of historical – and potential future - analysis of the man-seat-rail-roller interactions which could be re-analyzed, to check for motion restrictions caused by flexure or dynamics.
